Landslides (2013) 10:409–420
 DOI 10.1007/s10346-012-0329-5
 Received: 25 February 2011
 Accepted: 4 April 2012
 Published online: 22 May 2012
 © The Author(s) 2012. This article is
 published with open access at
 Springerlink.com

Riccardo Fanti · Giovanni Gigli · Luca Lombardi · Deodato Tapete · Paolo Canuti

Terrestrial laser scanning for rockfall stability analysis in the cultural heritage site of Pitigliano (Italy)

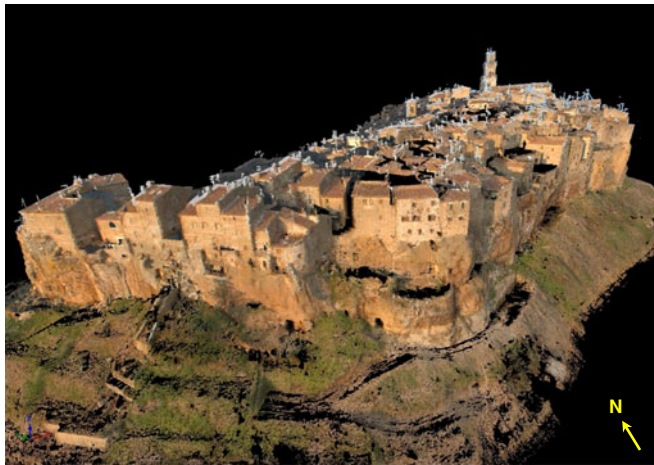
Fig. 4 Holistic true coloured point cloud of the Pitigliano cliff and the historic centre

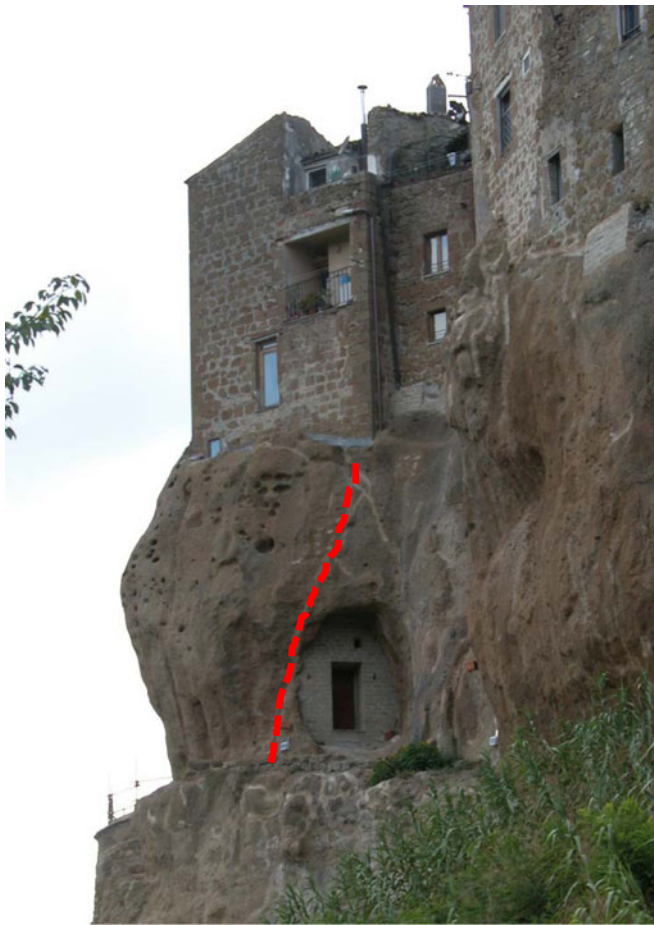
Fig. 14 Test area selected on the southern side of the Pitigliano cliff. Deformometers were installed to monitor the joint (*dashed line*) which controls the wedge geometry. Spatial relationship with the overlying building suggests probable direct impacts on the preservation of the built heritage

Figure 14 shows the test area where the buildings are built above a tuff block affected by a joint suggesting the presence of a probable plane of failure. Detachment of the block would compromise the stability of the overlying buildings, even causing structural collapses. A further element of instability is here constituted by the presence of the underground cave, whose excavation could have influenced the overall structural setting of the rock mass underneath the buildings. This case clarifies how a geomechanical analysis of instability mechanisms in built-up contexts requires a wider approach which would take into account all different geological and not-geological hazard factors.
